NIOSH
Fire Fighter Fatality Investigation
and Prevention Program

Two Career Fire Fighters Die in a Rapid Fire Progression While Searching for Tenants—Ohio

Executive Summary

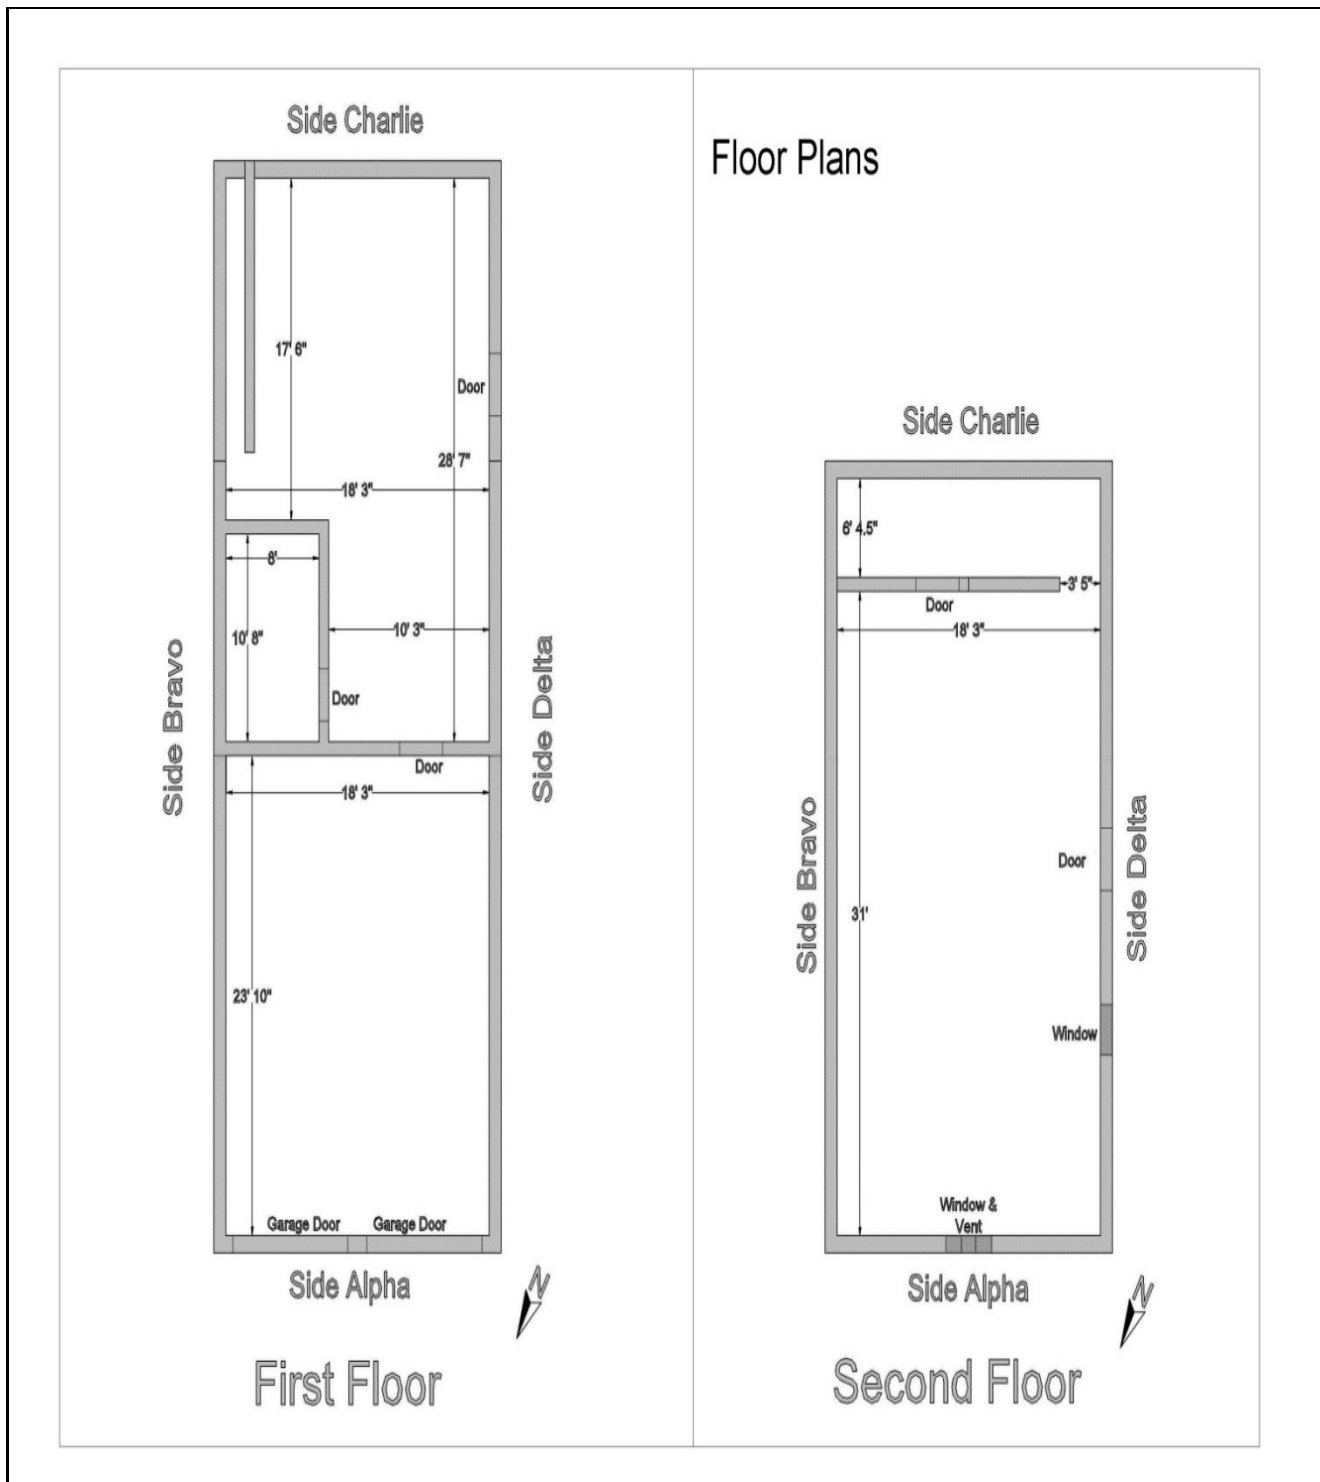
Diagram 1. Dimensional layout of the first and second floors of the fire structure.
(Diagram courtesy of the city's Engineering Services.)

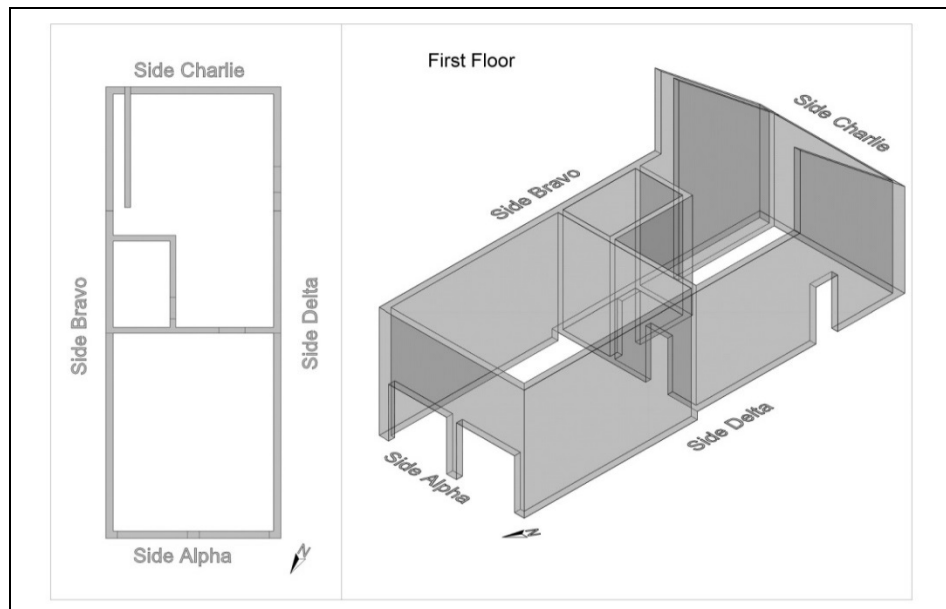
Diagram 2. First-floor three-dimensional view of the fire structure.
(Diagram courtesy of the city's Engineering Services.)

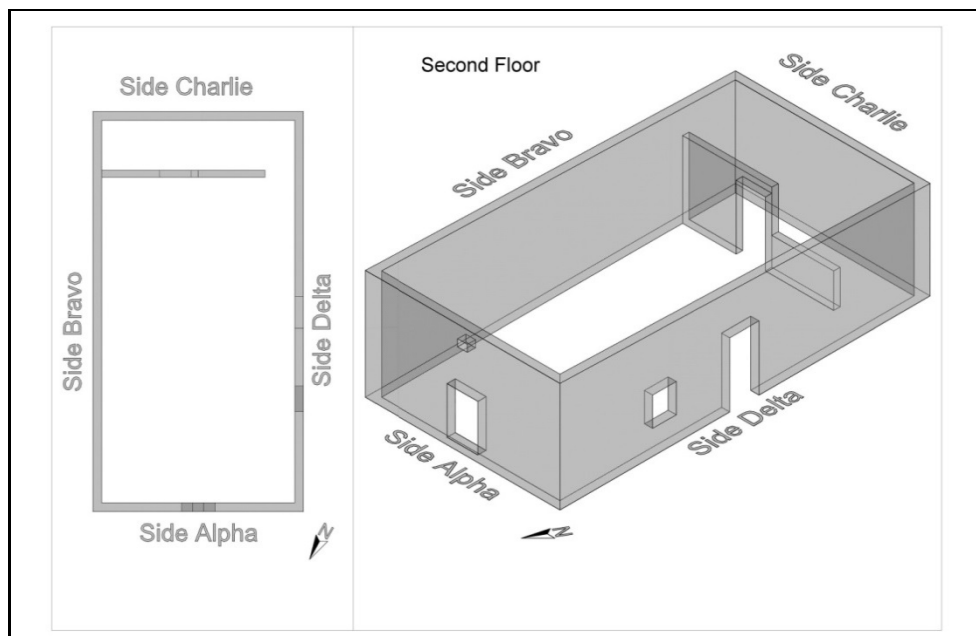
Diagram 3. Second-floor three-dimensional view of the fire structure.
(Diagram courtesy of the city's Engineering Services.)

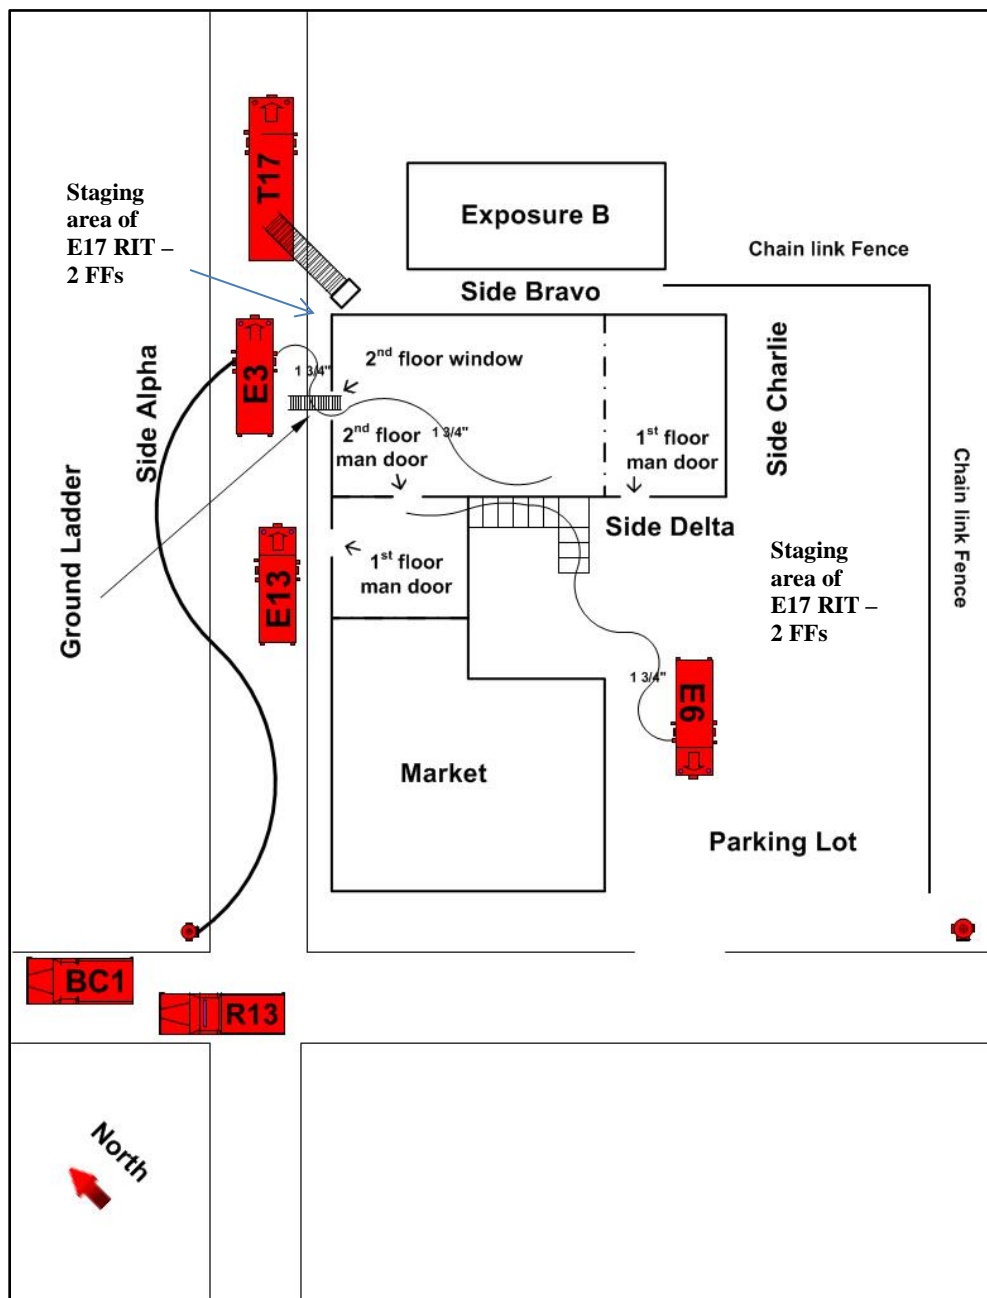
assigned search with Rescue 13 (see Diagram 4). *Note: Command was informed by an occupant at the scene that all occupants were out of their apartment but there was a dog on the second floor.* Engine 13 opened a first-floor Side Alpha apartment man-door on the Delta exposure of the garage.

Diagram 4. Initial apparatus placement and hoseline deployment of the first alarm companies.

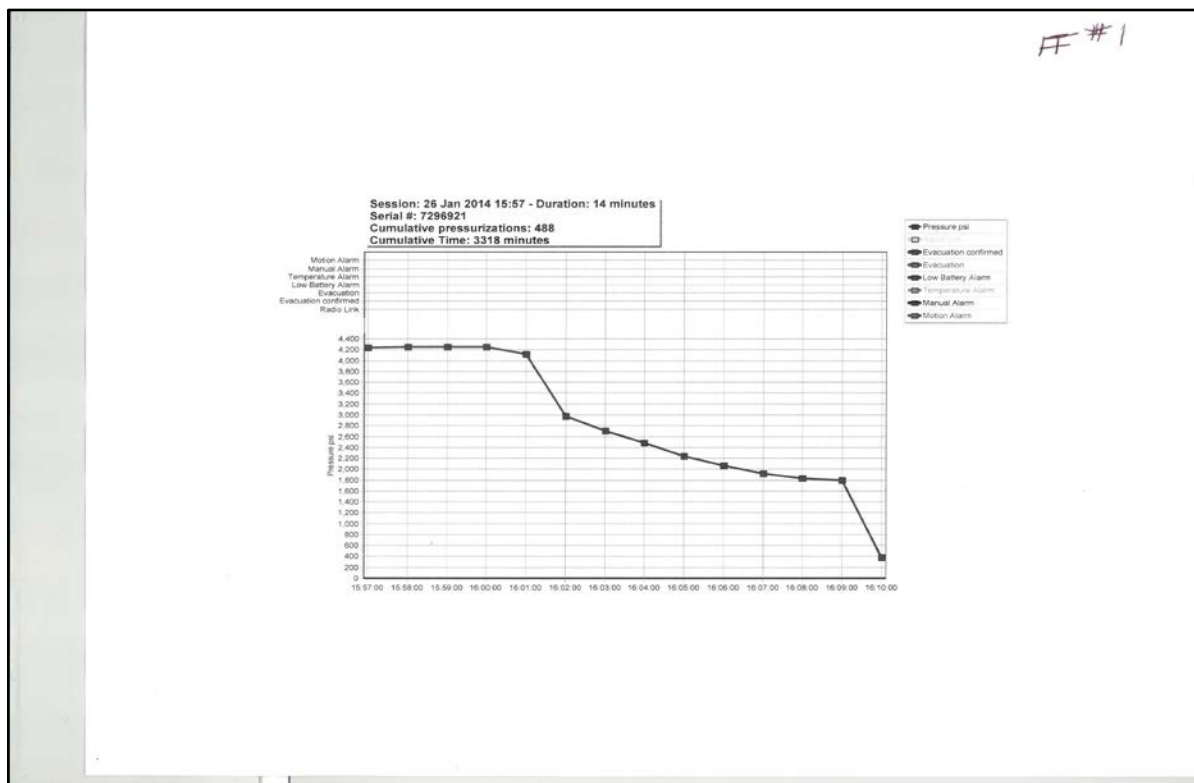
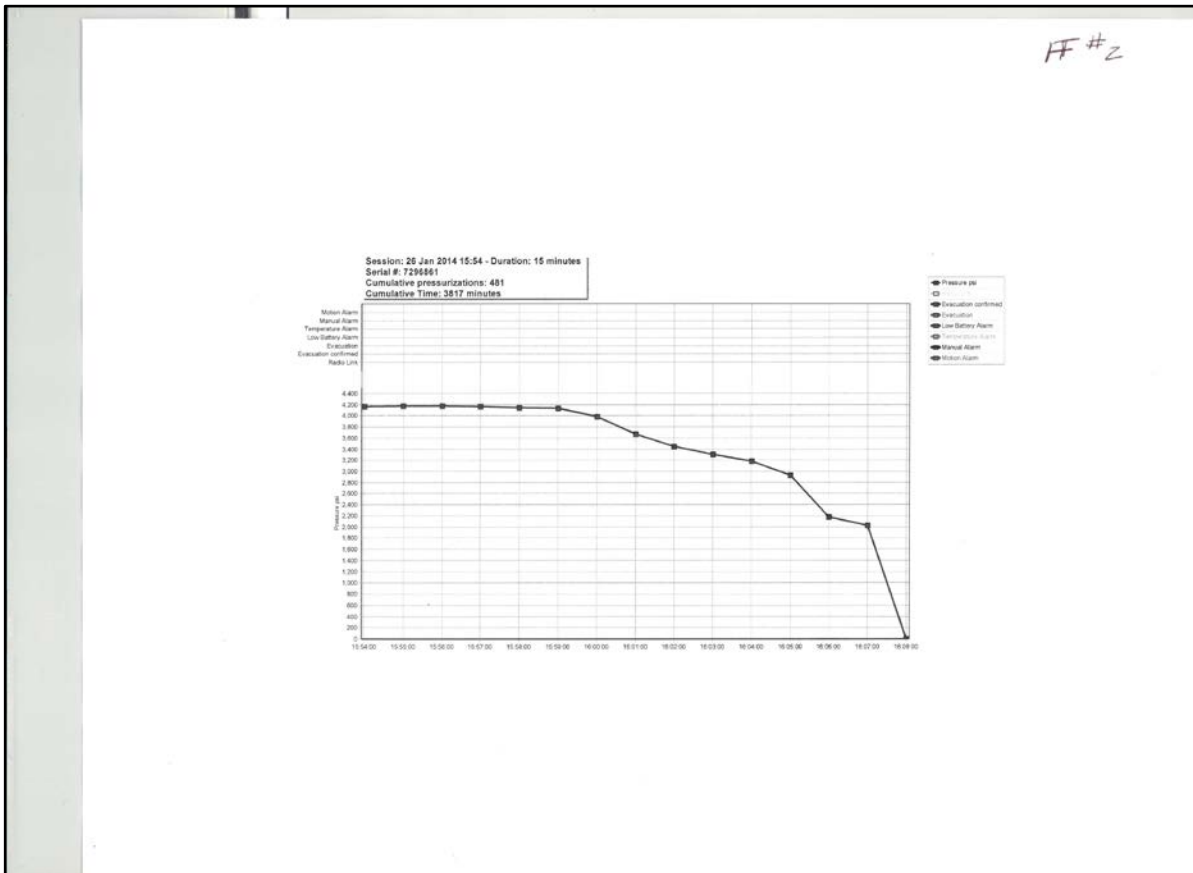
On June 19, 2014, representatives of the Mine Safety Appliances Company (MSA) down loaded the data loggers included with these SCBA units. The data downloads were performed at the MSA facility in Cranberry Township, Pennsylvania and the downloads were witnessed by NIOSH and Fire Department personnel. Attached are the SCBA cylinder pressure versus time charts for both fire fighters. Please note the cylinders were close to full and the duration was 14 minutes and 15 minutes, respectively. Places where the graph indicates a sudden drop in pressure suggests that that the by-pass was used for cool air, the face piece may have dislodged, or the face piece seal was broken by accident or on purpose.
